2019 Water Quality Monitoring Report

Report prepared by: Kristen
Balschunat & Gianna Petito
Winooski Natural Resources
Conservation District

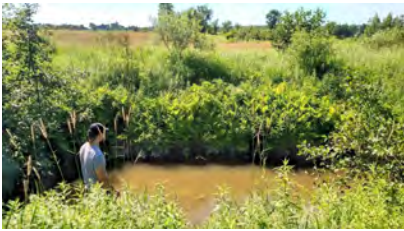
Alder Brook (1 site) This brook originates in agricultural headwaters and then winds through the Town of Essex. Our sampling is currently in the headwaters. The phosphorus values at this site have exceeded the standard for two years in a row. The chloride values are very low, likely because there is less impervious surface in this sub-watershed than other sites.

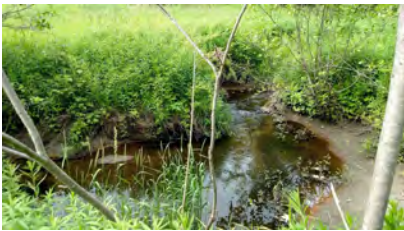
Allen Brook (1 site) "The headwaters of Allen Brook are in Milton west of Cobble Hill. The brook flows westerly and then southerly through the subdivisions of Milton along Route 7. After the brook crosses into the town of Colchester, it flows southeasterly for about a mile before curving sharply and going under Route 7 and into Malletts Creek Marsh."¹ This brook is not currently listed as impaired for stormwater, but there is growing concern that it may be heading in that direction. We were unable to collect samples this year due to challenges with site access, but are eager to help monitor the health of this stream in the coming years as the Town implements water quality improvement projects.

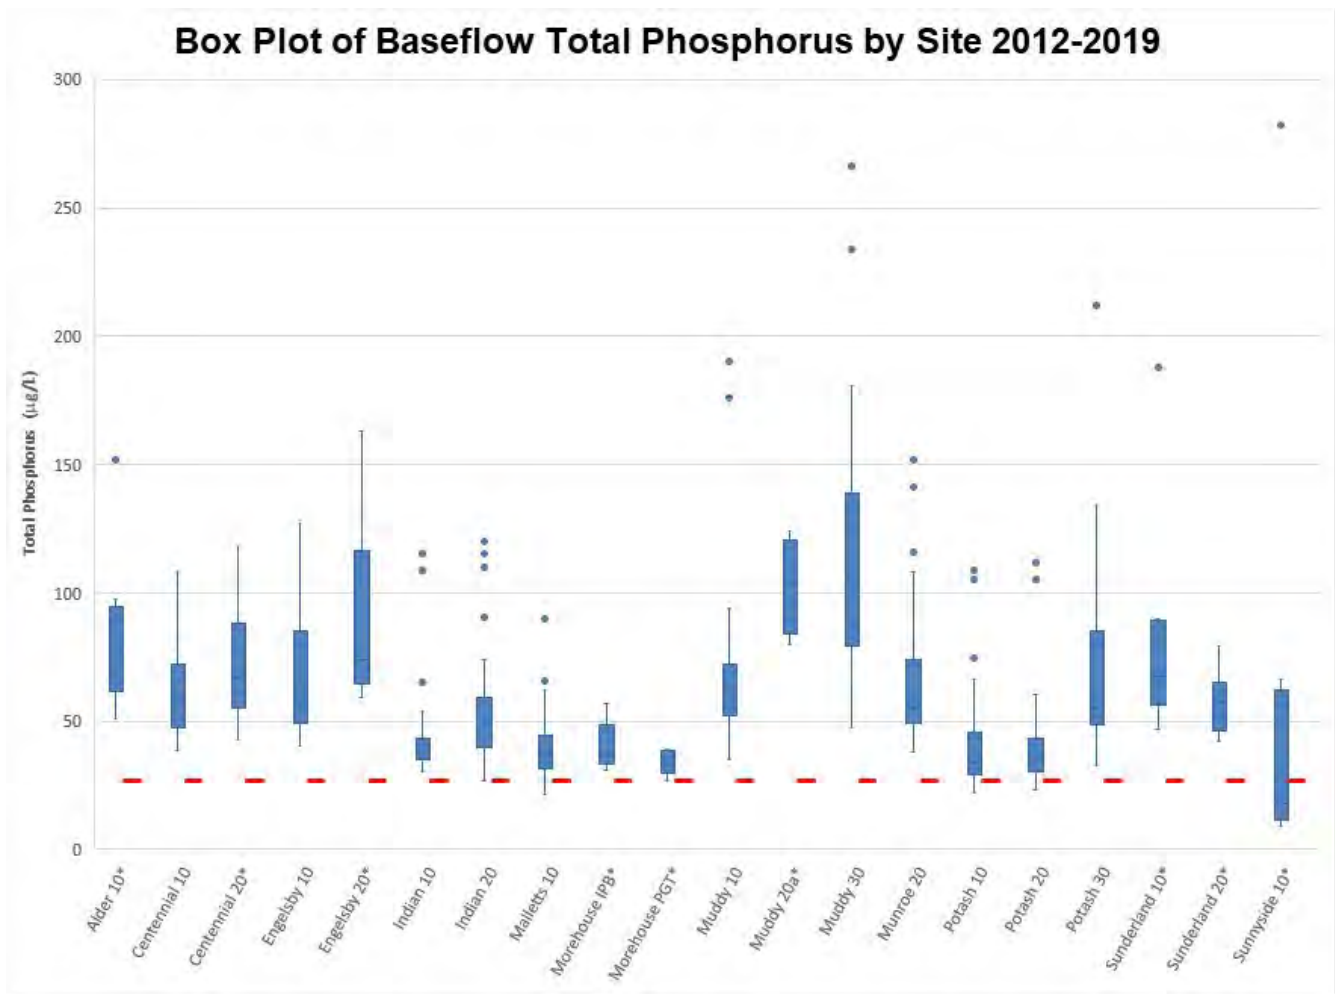
Figure 2. Comparison of total phosphorus levels across sites 2012-2019. Box plots indicate first and third quartiles and median values of total phosphorus concentrations for all sites. These values were calculated including sampling dates that may or may not have associated flagged dupe or blank samples. Asterixed sites indicate 1-3 years of sampling data, all other sites represent 7-8 years of sampling data. Dots indicate outliers which were identified as equal to or greater than 1.5 times the site's interquartile range. Red line indicates Vermont's 2016 Water Quality Standard of 27 µg/L. Three outliers were excluded from this graph for easier viewing: Centennial 10, 6/25/19, 845 µg/L, Centennial 20, 6/25/19 364 µg/L, Muddy 10, 6/25/13, 339 µg/L. Note that box plots do not reveal trends over time but, rather, aggregate many years of data to provide a more comprehensive view of each stream's condition.

Since the onset of this monitoring program in 2012, mean and/or median concentrations of phosphorus during baseflow have remained notably above the 27 µg/L standard at all stream sites. In fact only 5 out of the 20 sites sampled in 2019 have ever exhibited phosphorus concentrations below this standard (Indian 20, Malletts 10, Potash 10 and 20, and Sunnyside 10). Out of these 5, only one site (Sunnyside 10) reports a median below the standard but the 2-yr sampling mean still falls above the standard. Sites of notable historic levels include Engelsby 20, Muddy 10 and 30, Munroe 20, Potash 30, and Sunderland 10 although newer sites like Alder 10, Muddy 20a, Sunderland 10 and Sunnyside 10 have some alarming medians and/or outliers.

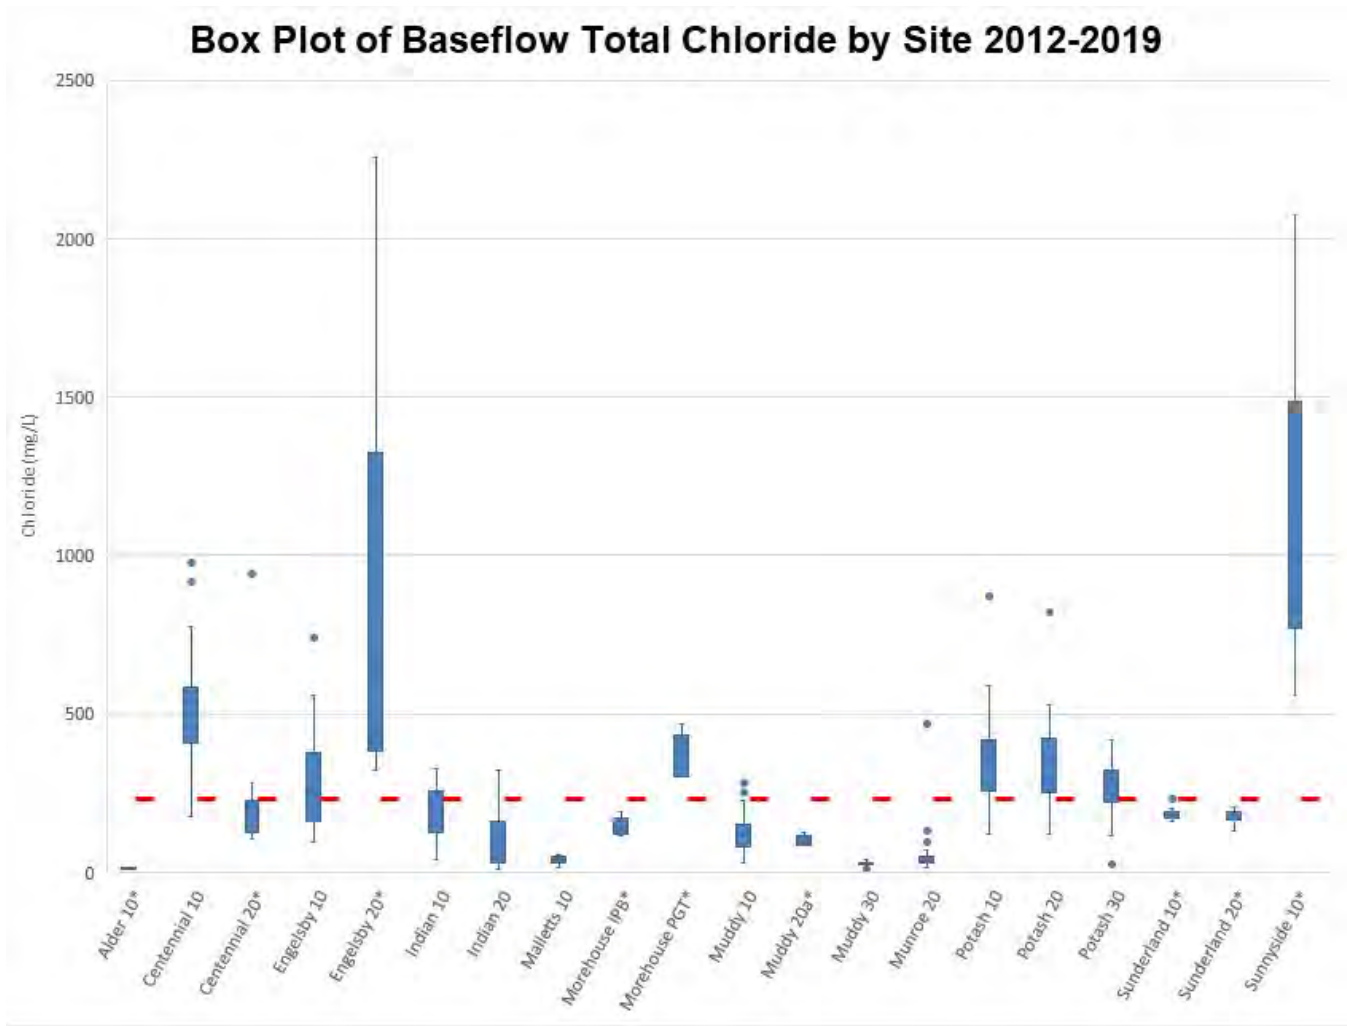
Figure 5 - Comparison of Chloride levels across sites 2012-2019. Box plots indicate first and third quartiles and median values of chloride levels (mg/L) for all sites. Asterixed sites indicate 1-3 years of sampling data, all other sites represent 7-8 years of sampling data. Dots indicate outliers which were identified as equal to or greater than 1.5 times the site's interquartile range. Red line indicates EPA's and Vermont's standard for 4-day average chloride levels (230 mg/L). Note that box plots do not reveal trends over time but, rather, aggregate many years of data to provide a more comprehensive view of each stream's condition.

Since the onset of this monitoring program, mean chloride levels at Centennial 10 and Potash 10, 20 and 30 have remained notably above 230 mg/L. Recently added sampling sites have also presented alarmingly high data including Engelsby 20, Morehouse PGT, and Sunnyside 10.

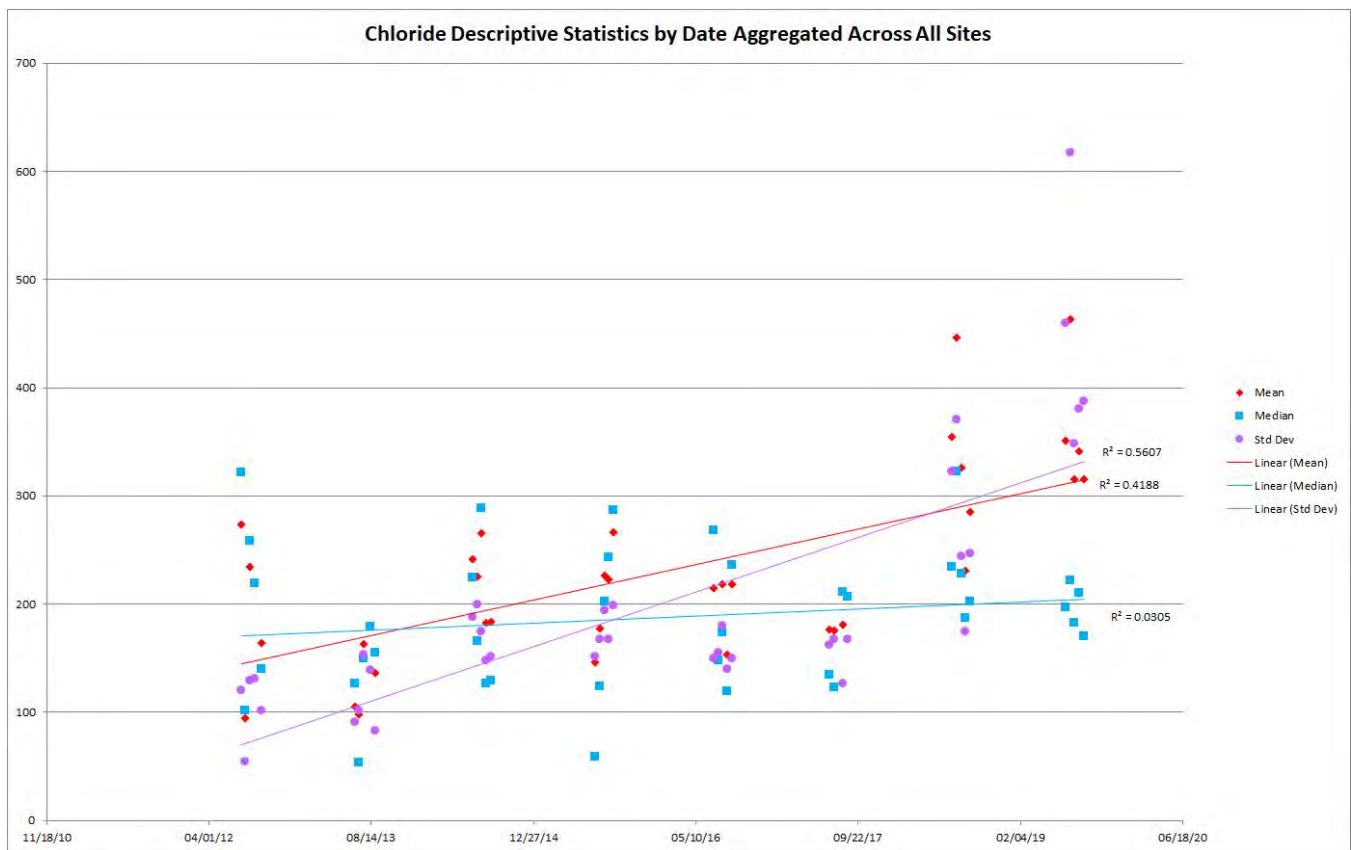
Figure 6. Descriptive Statistics for chloride data gathered across sites aggregated by date. Each sampling date had chloride values across sites averaged to determine mean, median, and standard deviation for the entire sampling area.

Aggregated data also suggests a general increasing trend in chloride. Figure 6 below shows that the mean and standard deviation values have increased slightly over time (although medians are holding relatively constant). Also, notably, the R² value of the best fit line for the mean and standard deviation have both increased from 2018 values; from 0.32 to 0.42, and from 0.45 to 0.56 respectively. This suggests that as we add more years of data, this increasing trend is gaining significance. With medians remaining somewhat constant this is suggesting an increase in more extreme values.

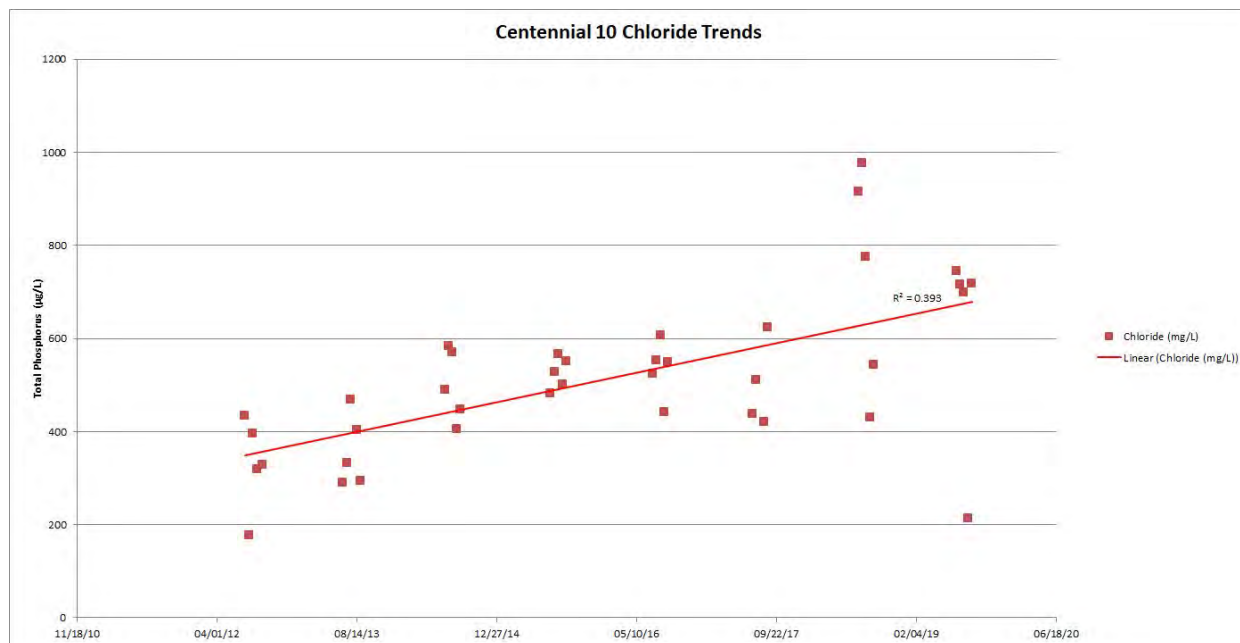
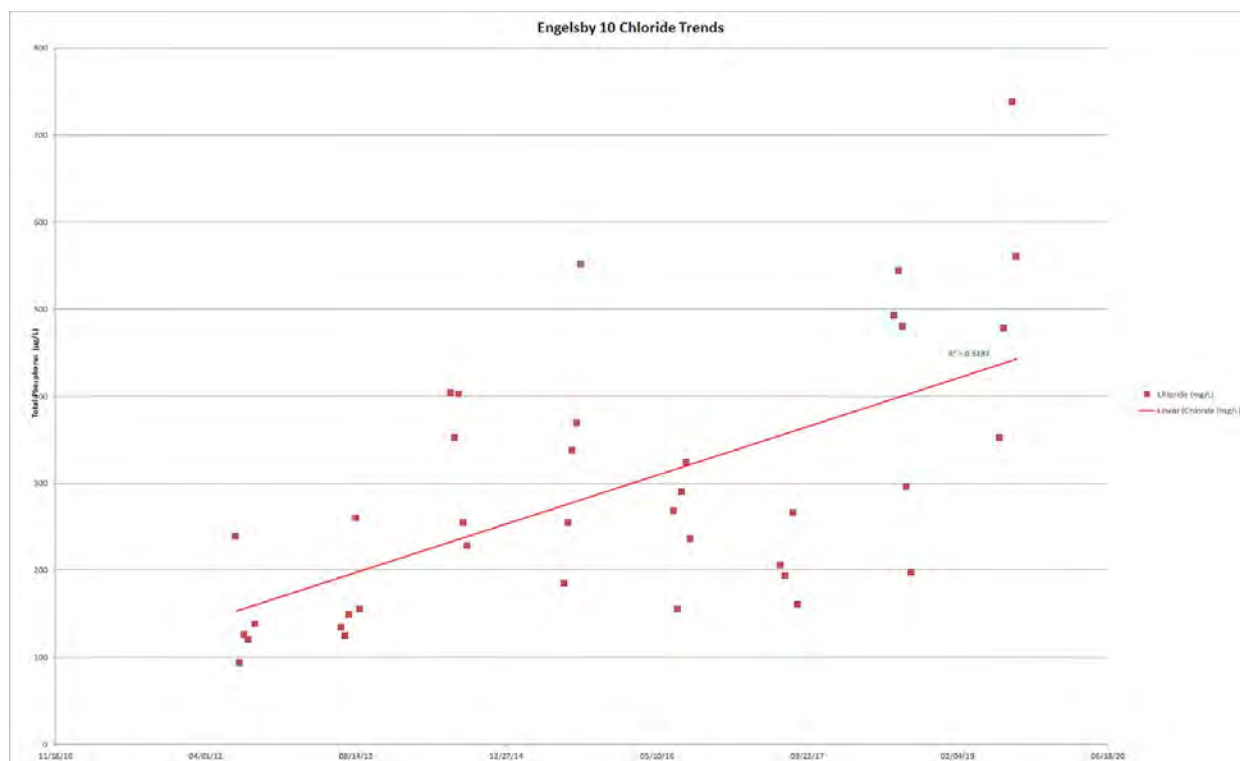
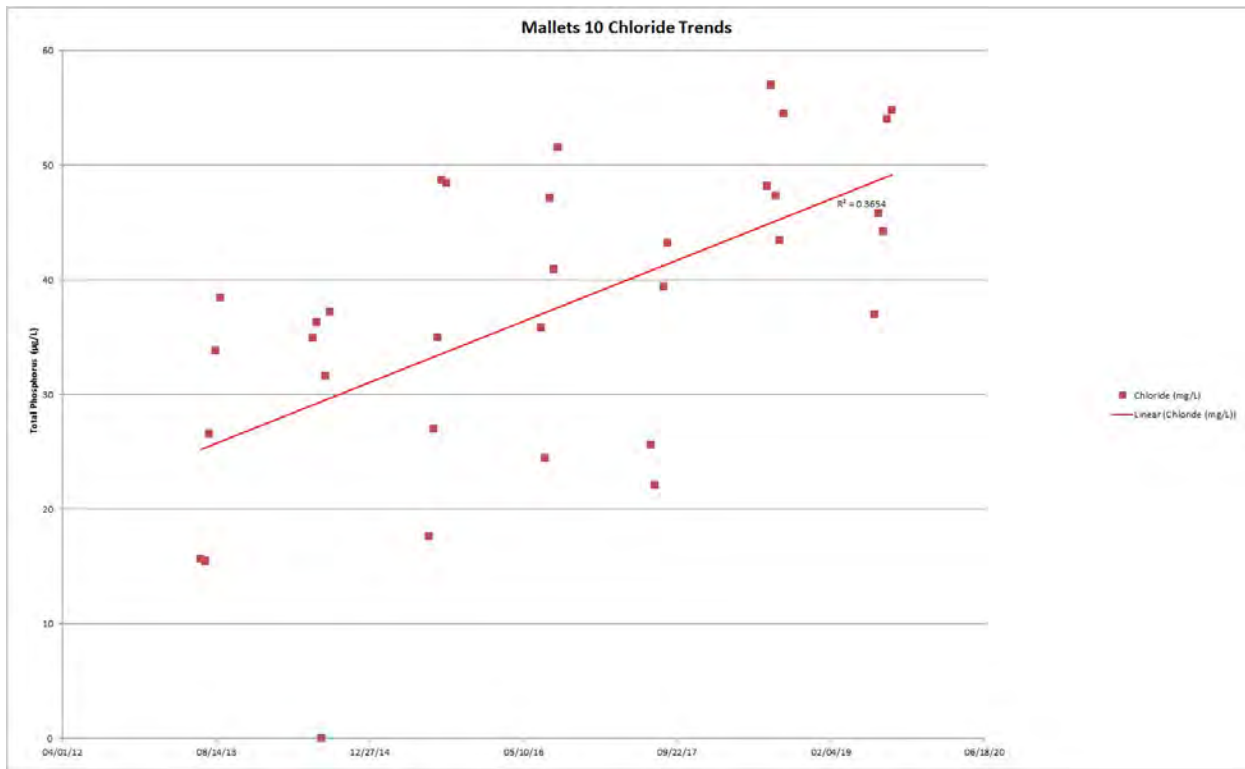
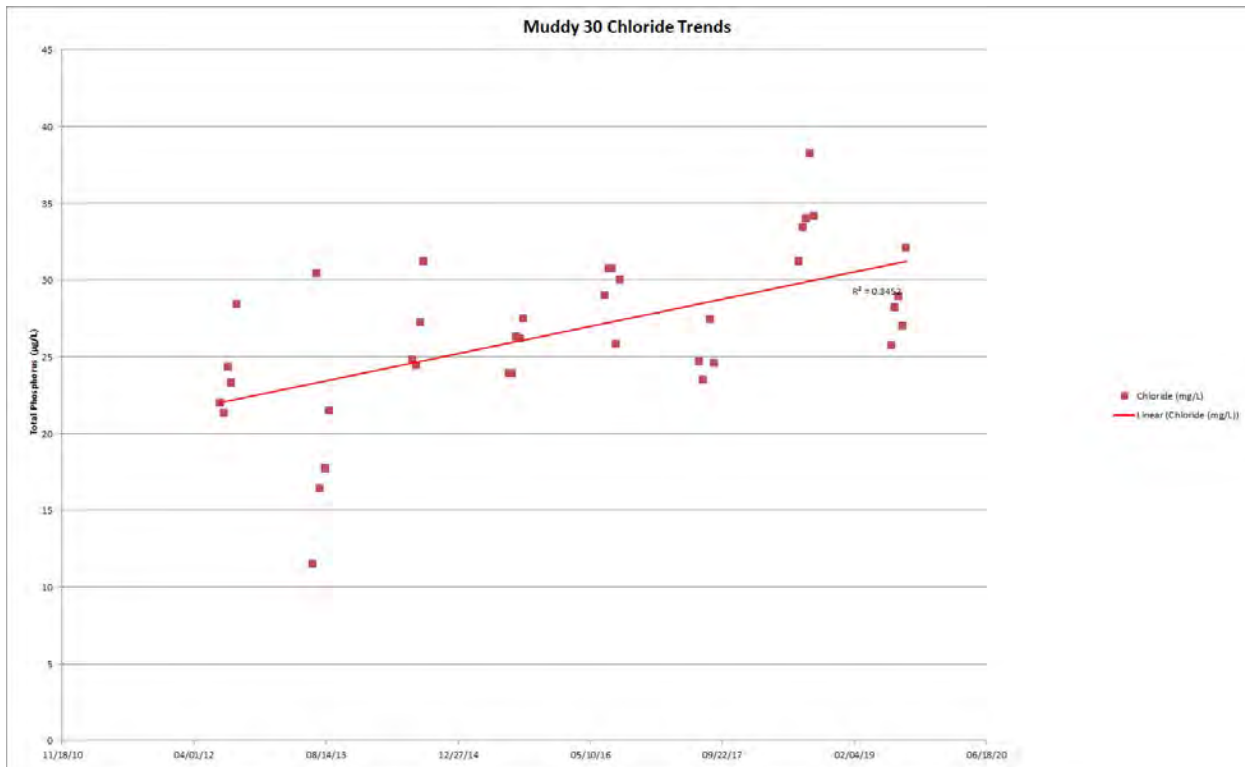
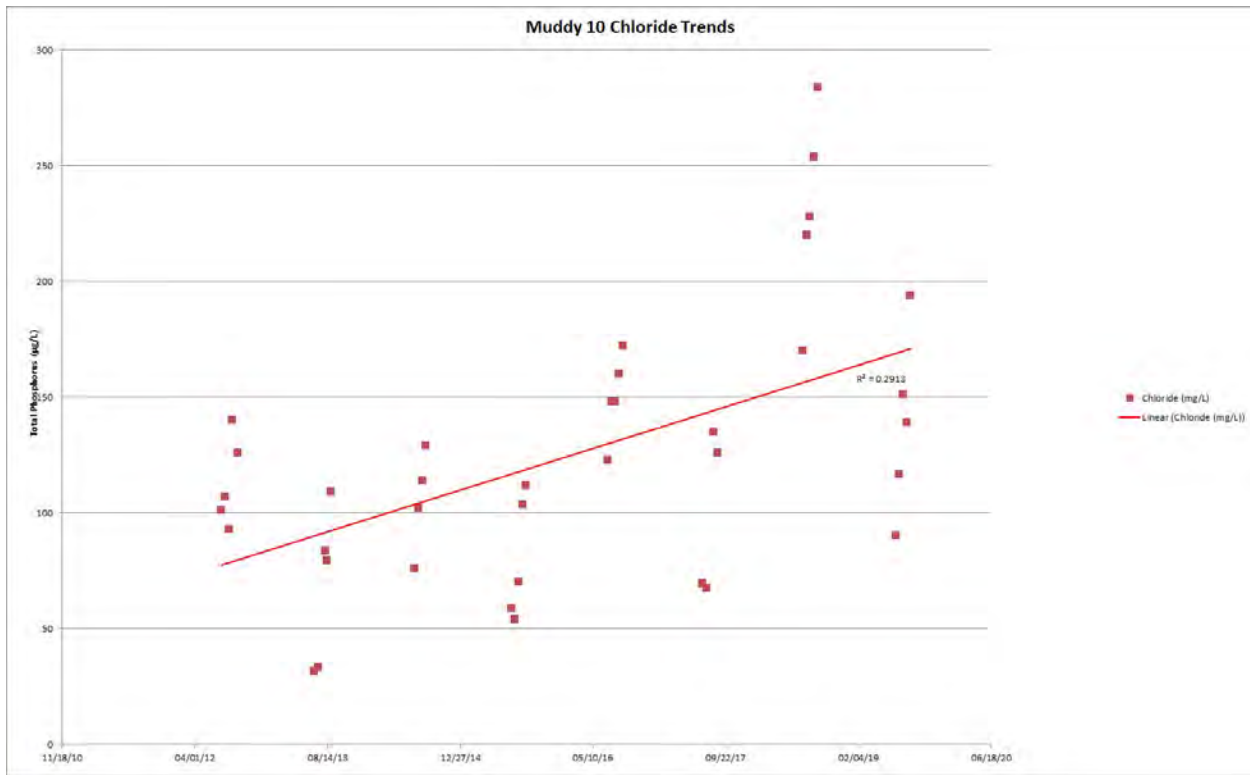
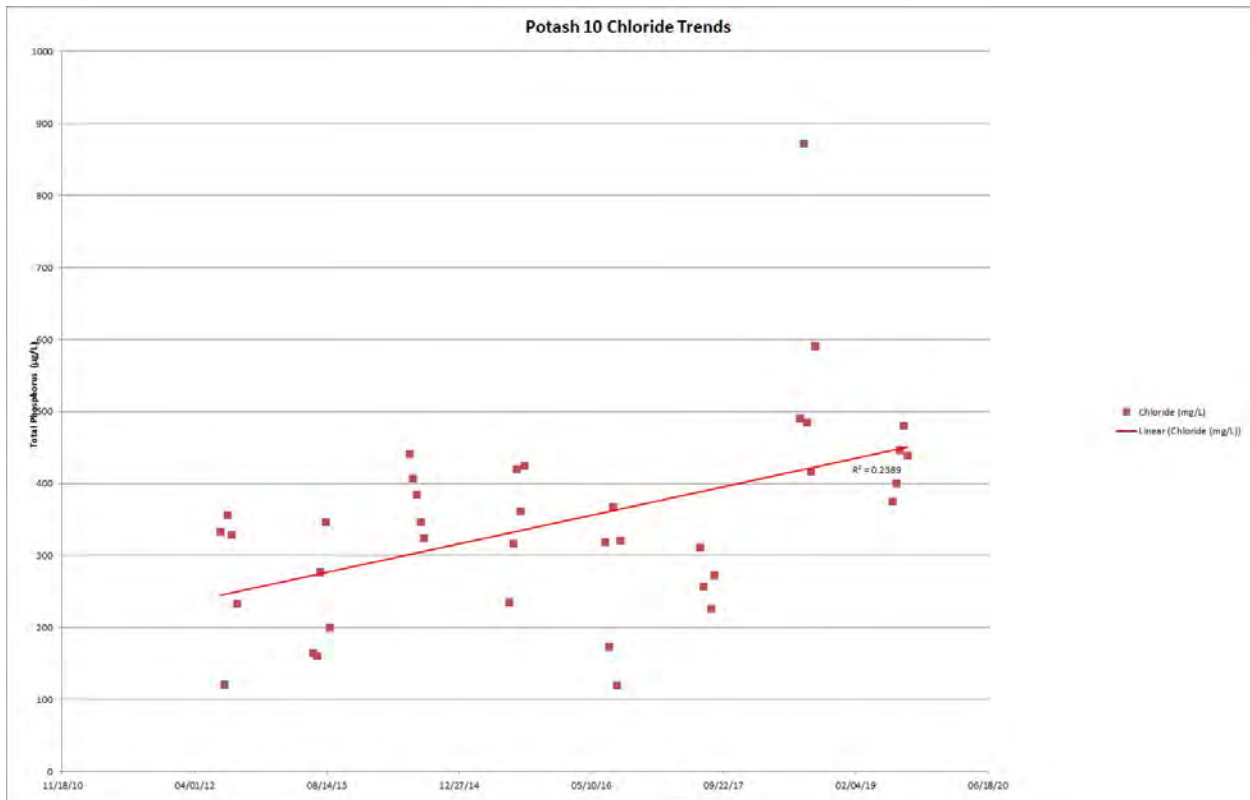
Appendix D. Notable Trends in Chloride Increases Over Time By Site. Sorted in descending order by R2 values.
