2018 Water Quality Monitoring Report

The Rethink Runoff Stream Team (formerly known as the Chittenden County Stream Team) is a program that engages citizens across a nine-municipality region to implement projects that reduce non-point source pollution and stormwater volume at the local level. The participating towns are Burlington, Colchester, Essex, Essex Junction, Milton, Shelburne, South Burlington, Williston, and Winooski. The Water Quality Monitoring program is managed by the Chittenden County Regional Planning Commission Clean Water Advisory Committee MS4 subcommittee, coordinated by the Winooski Natural Resources Conservation District, and made possible through the support of the Vermont Department of Environmental Conservation LaRosa program. This report describes the results from the 2018 collection season; the seventh, consecutive year data was collected by this volunteer-led stream water quality monitoring effort in Chittenden County.

Report prepared by: Kristen
Balschunat & Gianna Petito
Winooski Natural Resources
Conservation District

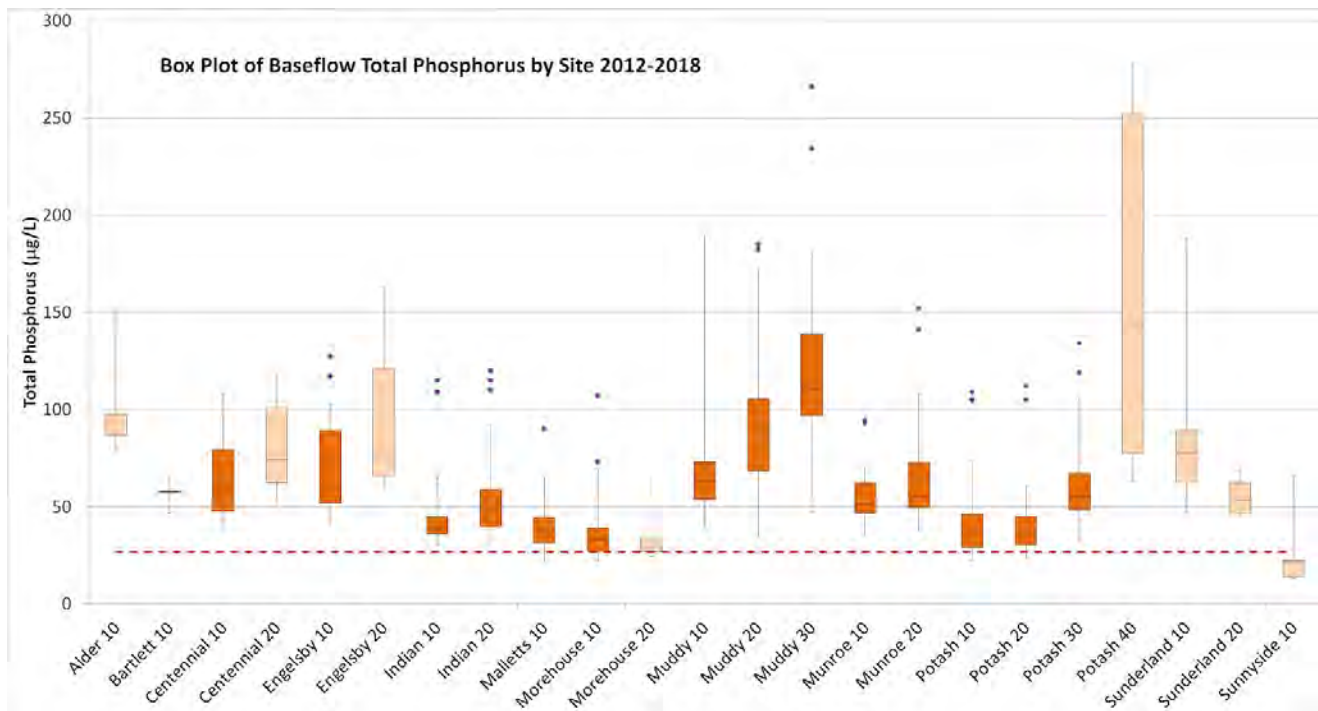
Figure 2. Comparison of total phosphorus levels across sites 2012-2018. Box plots indicate first and third quartiles and median values of total phosphorus concentrations for all sites. These values were calculated including sampling dates that may or may not have associated flagged dupe or blank samples. Lighter colored boxes indicate 1-2 years of sampling data, darker boxes indicate 6-7 years of sampling data. Dots indicate outliers which were identified as equal to or greater than 2 times the site's standard deviation. Red line indicates Vermont's 2016 Water Quality Standard of 27 micrograms/L.

Figure 2 suggests that phosphorus levels increase as sampling moves upstream. To test this hypothesis, RRST used scatter plots to graph phosphorus data over time by stream and ran statistical analyses on 8 streams that had more than one sampling site. Of the 8 streams that have more than one sampling location, 6 indicated a statistically significantly different value of phosphorus between sites, all of which presented statistically significantly higher concentrations of total phosphorus upstream. Table 4 summarizes the results of these tests. Appendix D summarizes statistics and graph visualizations. This result was somewhat surprising and merits more consideration since we assumed that total phosphorus increased in concentration as water moves downstream and more inputs are introduced.

Figure 2 also suggests that Muddy Brook has shown consistently high levels of Phosphorus as compared to other sites including some extremely high outliers. Interestingly, temporal data is suggesting a non-significant downward trend of Phosphorus concentrations at sites Muddy 20 and Muddy 30 with Muddy 10 holding relatively constant. This is unique to Muddy Brook and it's not clear what land use changes or restoration efforts could have contributed to this. Figures 3 and 4 show the suggested trends for Muddy 20 and 30 respectively.

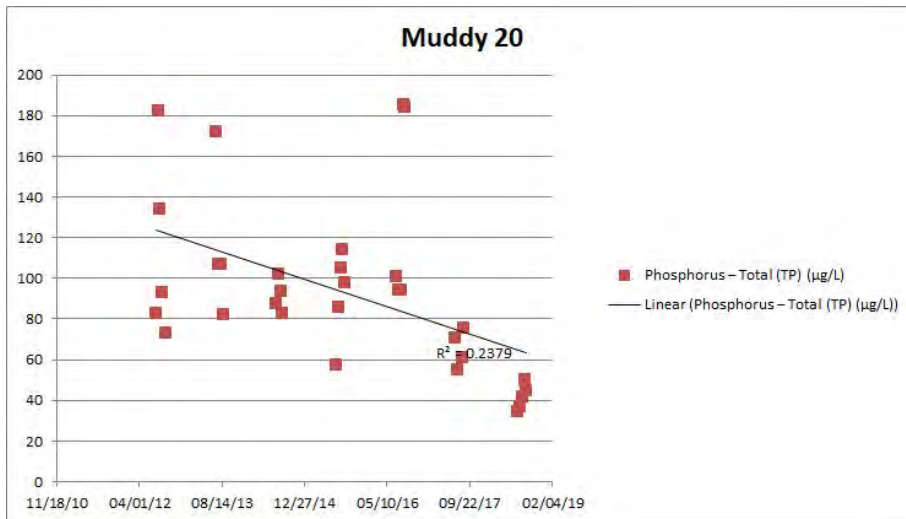
Figure 3. Total Phosphorus in Muddy 20 since 2012. Scatter plot visually suggests a downward trend but R2 of the best fit line is still only about 0.24 and not significant.

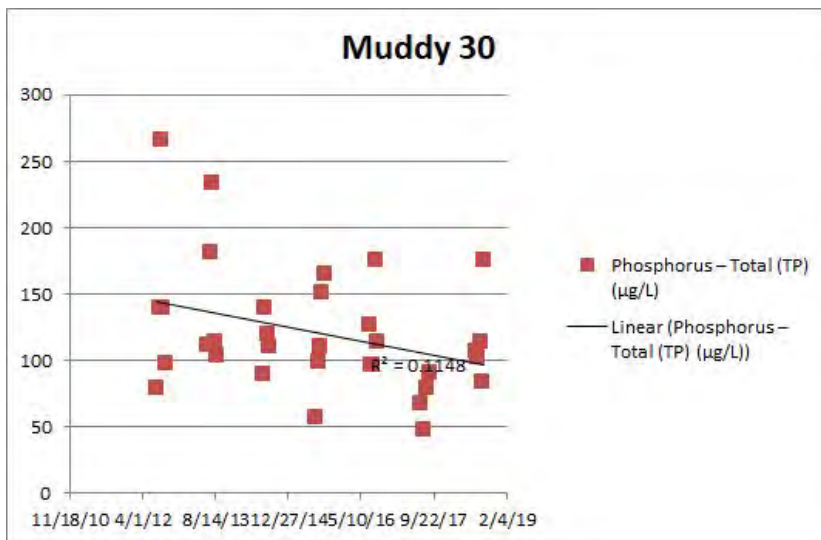
Figure 4. Total Phosphorus in Muddy 30 since 2012. Scatter plot visually suggests a downward trend but R2 of the best fit line is still only about 0.12 and not significant.

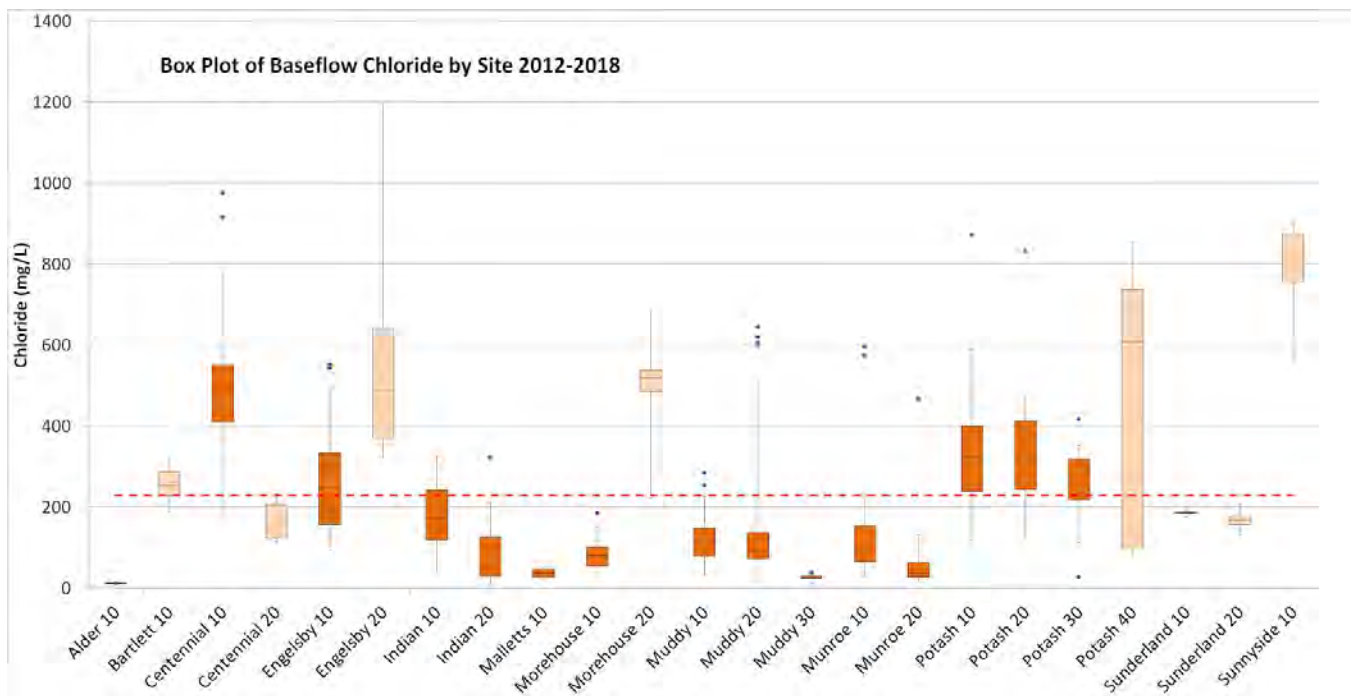
Figure 5 - Comparison of Chloride levels across sites 2012-2018. Box plots indicate first and third quartiles and median values of chloride levels (mg/L) for all sites. Lighter colored boxes indicate 1-2 years of sampling data, darker boxes indicate 6-7 years of sampling data. Dots indicate outliers which were identified as equal to or greater than 2 times the site's standard deviation. EPA's and Vermont's standard for 4-day average chloride levels (230 mg/L) is shown by the red line.

Since the onset of this monitoring program, mean chloride levels at Centennial 10 and Potash 10, 20 and 30 have remained notably above 230 mg/L standard. Recently added sampling sites have also presented alarmingly high data including Engelsby 20, Morehouse 20, Potash 40, and Sunnyside 10.

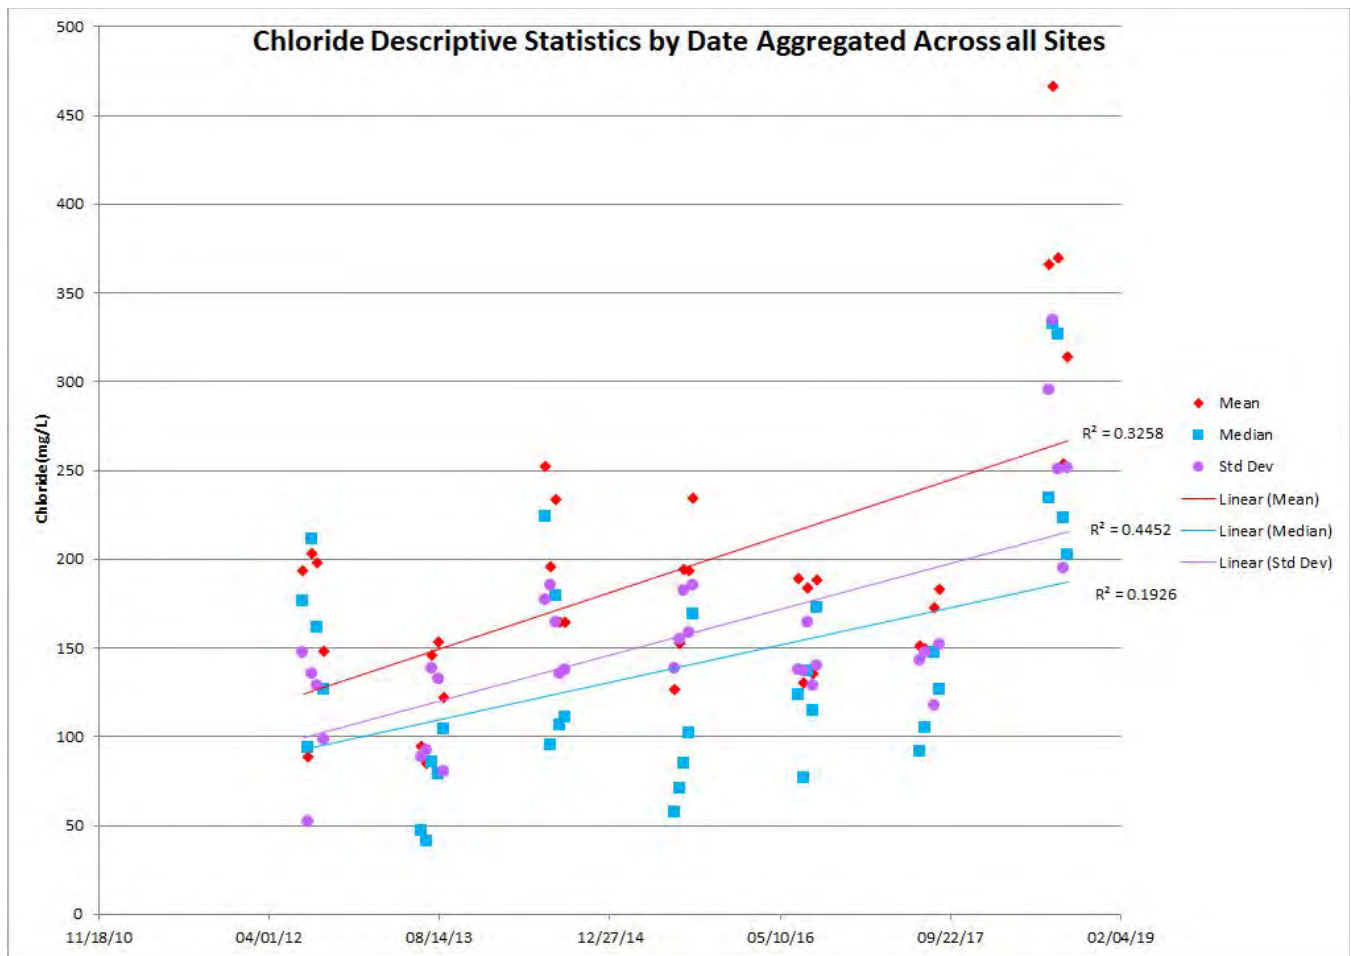
Figure 6. Descriptive Statistics for chloride data gathered across sites aggregated by date. Each sampling date since June 2016 had chloride values across sites averaged to determine mean, median, and standard deviation for the entire sampling area.

Aggregated data also suggests a general increasing trend in chloride. Figure 6 below shows that the mean, median, and standard deviation values have all increased slightly over time.

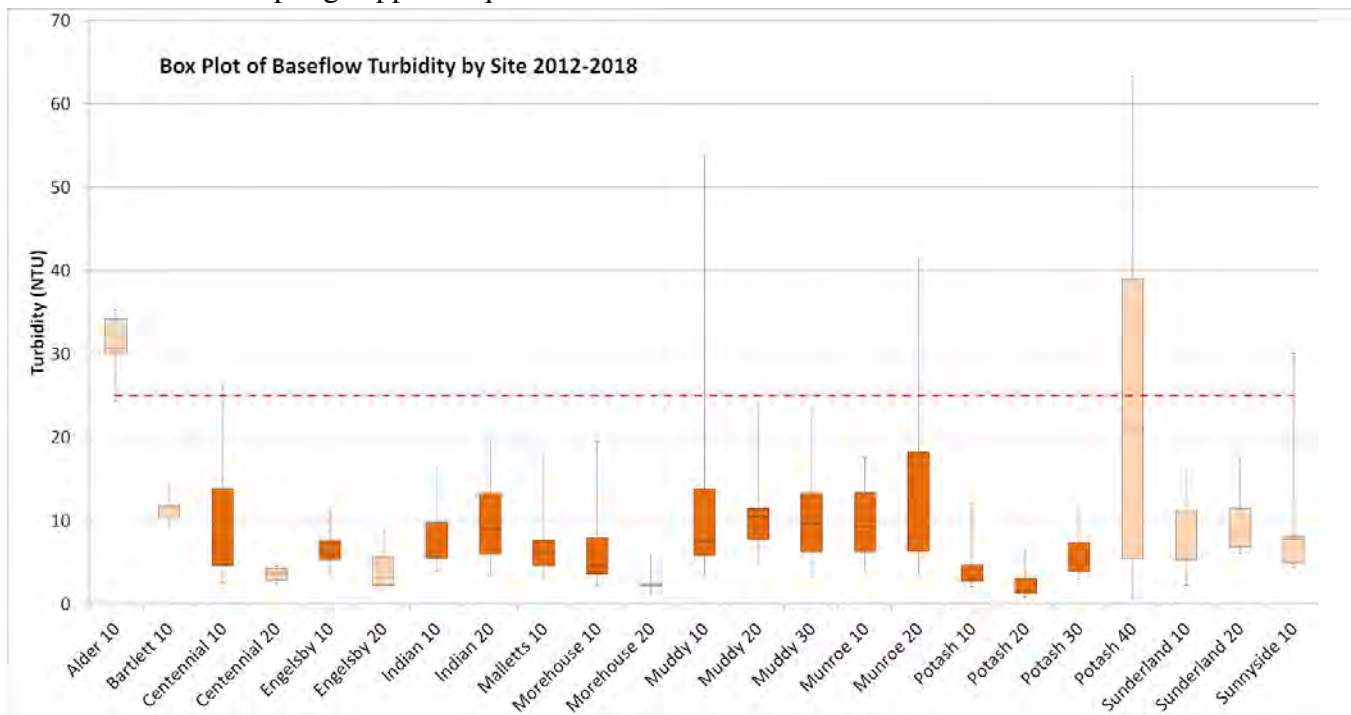
Figure 7 - Comparison of turbidity levels 2012-2018 during baseflow (dry) conditions. The standard proposed by the State of Vermont for mean turbidity at baseflow in medium gradient, warm water streams (25 NTU) is indicated by the red line. These values were calculated including sampling dates that may or may not have associated flagged dupe or blank samples.

Mean, baseflow turbidity values have only rarely exceeded the VT standard for warm-water streams of 25 NTU over the seven year sampling period. Of note, however, is the high turbidity recorded for new sampling sites Alder 10 and Potash 40. Higher turbidity in Alder 10 is not surprising because the site is comparatively more agricultural with a couple farms and potential field runoff nearby. Turbidity has not been included in sampling support requests for the 2019 field season but will be revisited in 2020.

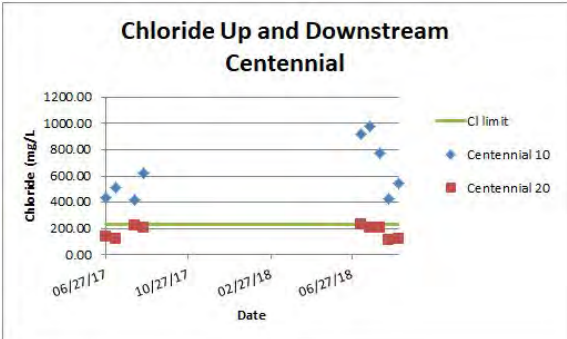
Centennial	0, 6, 0.05

<p>Chloride Up and Downstream Centennial</p> <p>This scatter plot shows chloride levels (mg/L) for Centennial 10 (blue diamonds) and Centennial 20 (red squares) from 06/27/17 to 06/27/18. A green horizontal line indicates the chloride limit at approximately 200 mg/L. Centennial 10 readings are generally higher than the limit, peaking at nearly 1000 mg/L in late 2017. Centennial 20 readings are mostly below the limit, with a notable spike to about 250 mg/L in early 2018.</p>
Engelsby	0, 6, 0.05

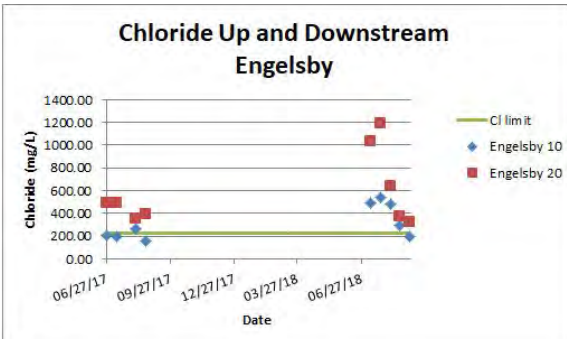
<p>Chloride Up and Downstream Engelsby</p> <p>This scatter plot shows chloride levels (mg/L) for Engelsby 10 (blue diamonds) and Engelsby 20 (red squares) from 06/27/17 to 06/27/18. A green horizontal line indicates the chloride limit at approximately 200 mg/L. Engelsby 10 readings are mostly below the limit, with a peak of about 500 mg/L in late 2017. Engelsby 20 readings show a significant spike to over 1200 mg/L in early 2018.</p>

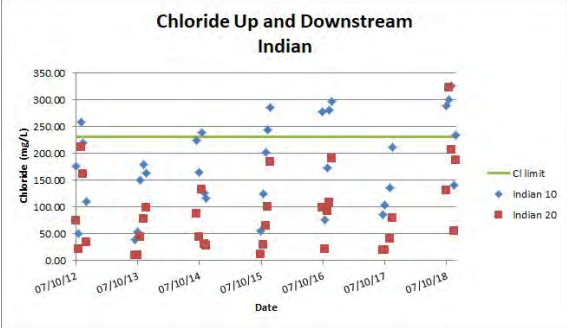
Indian	1, 187, 0.05

<p>Chloride Up and Downstream Indian</p> <p>This scatter plot shows chloride levels (mg/L) for Indian 10 (blue diamonds) and Indian 20 (red squares) from 07/10/12 to 07/10/18. A green horizontal line indicates the chloride limit at approximately 250 mg/L. Indian 10 readings are consistently above the limit, ranging from about 100 to 300 mg/L. Indian 20 readings are mostly below the limit, with a peak of about 200 mg/L in late 2017.</p>
Morehouse	0, 1, 0.1

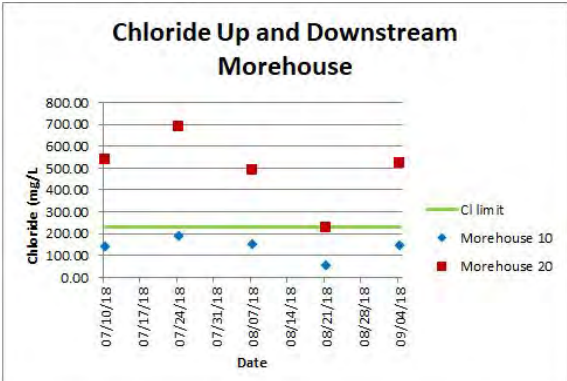
<p>Chloride Up and Downstream Morehouse</p> <p>This scatter plot shows chloride levels (mg/L) for Morehouse 10 (blue diamonds) and Morehouse 20 (red squares) from 07/10/18 to 09/04/18. A green horizontal line indicates the chloride limit at approximately 200 mg/L. Morehouse 10 readings are consistently below the limit, ranging from about 100 to 200 mg/L. Morehouse 20 readings show a peak of about 700 mg/L in late July 2018.</p>

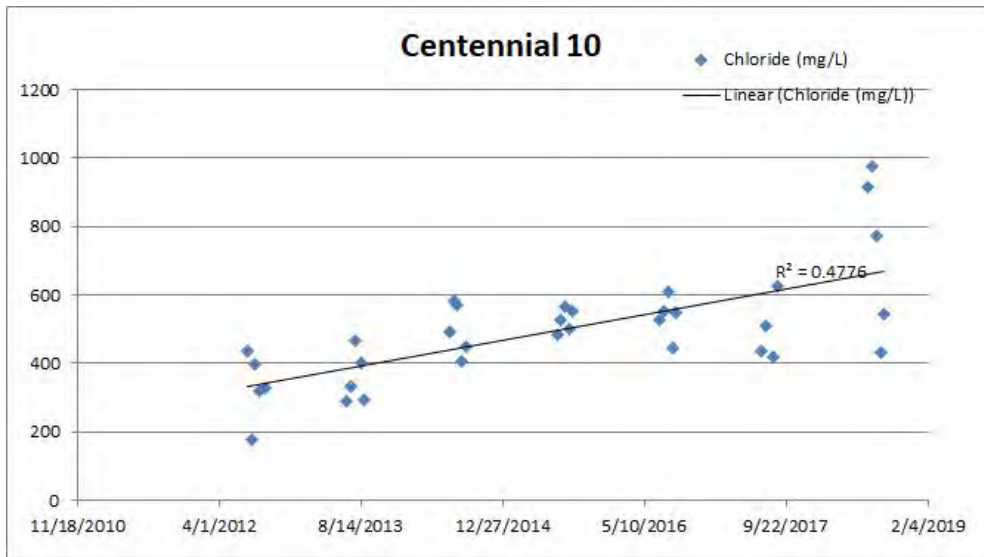
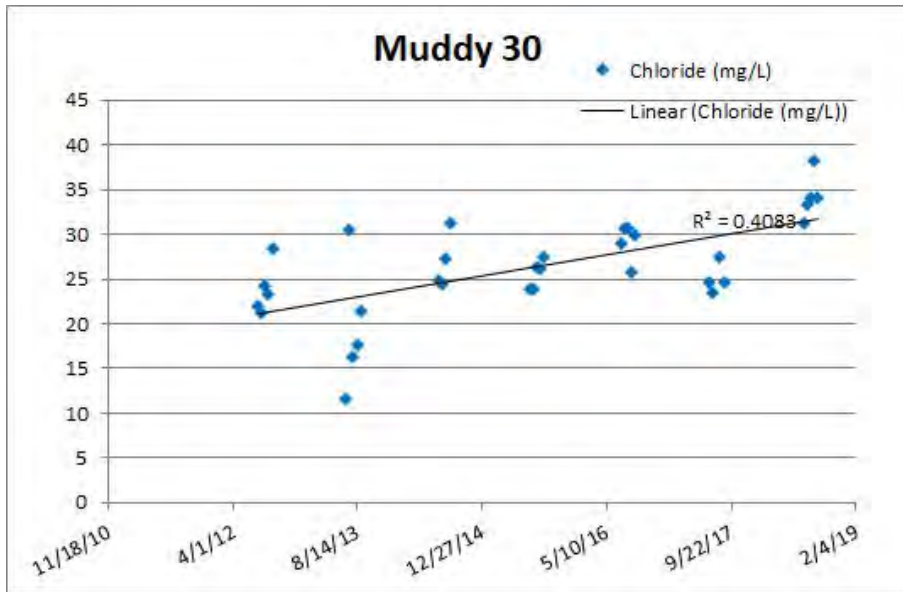
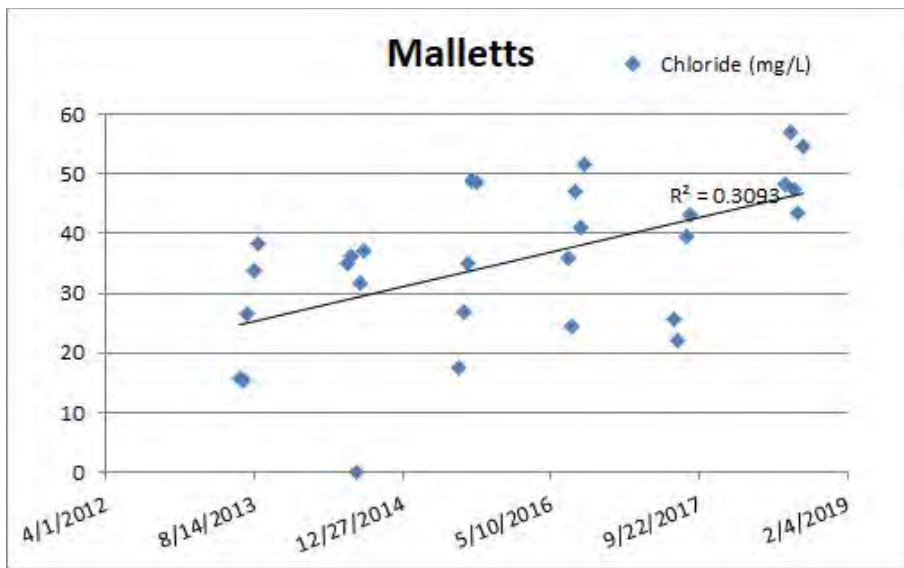
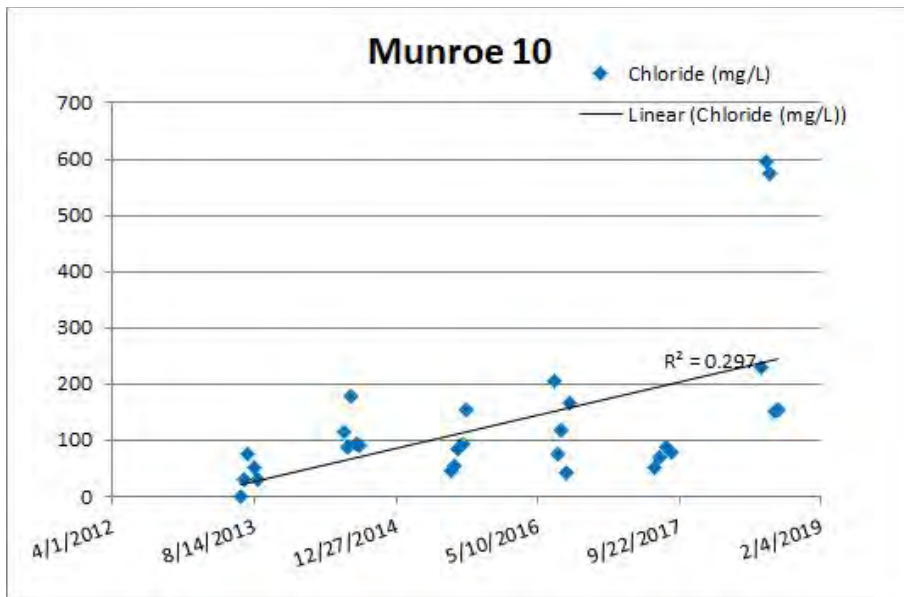
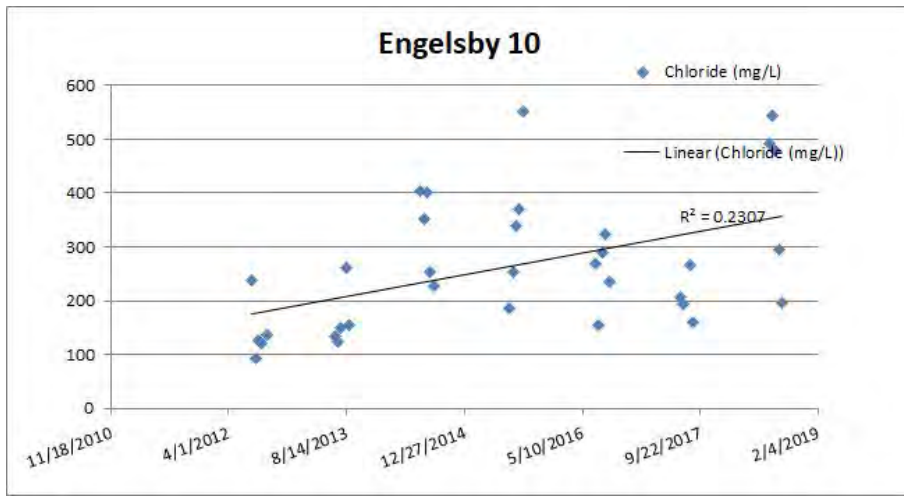
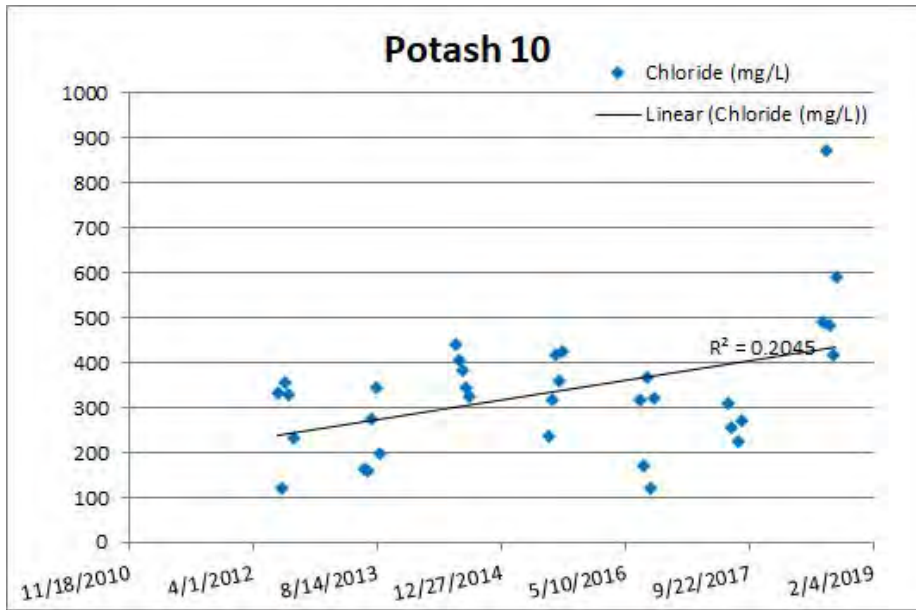
Appendix F. Notable Trends in Chloride Increases Over Time By Site. Sorted in descending order by R2 values.

Chloride data from this sampling program suggests that of the 14 sites that have been sampled for 6 or more years, chloride levels are trending upwards in 10 of them (Centennial 10, Engelsby 10, Indian 10 and 20, Malletts 10, Muddy 30, Munroe 10 and 20, and Potash 10 and 20). These trends are not statistically significant but highlight an important stressor to monitor closely. Appendix F documents graphs of these trends.
